Application of UAV for Sewer Pipe Inspection

Yusuke Inagaki, Hiroshi Ikeda, Yoshihiko Yato, Patrik Ken Takeuchi and Masatoshi Anakura*

NJS Co., Ltd., Minato-ku, Tokyo, Japan

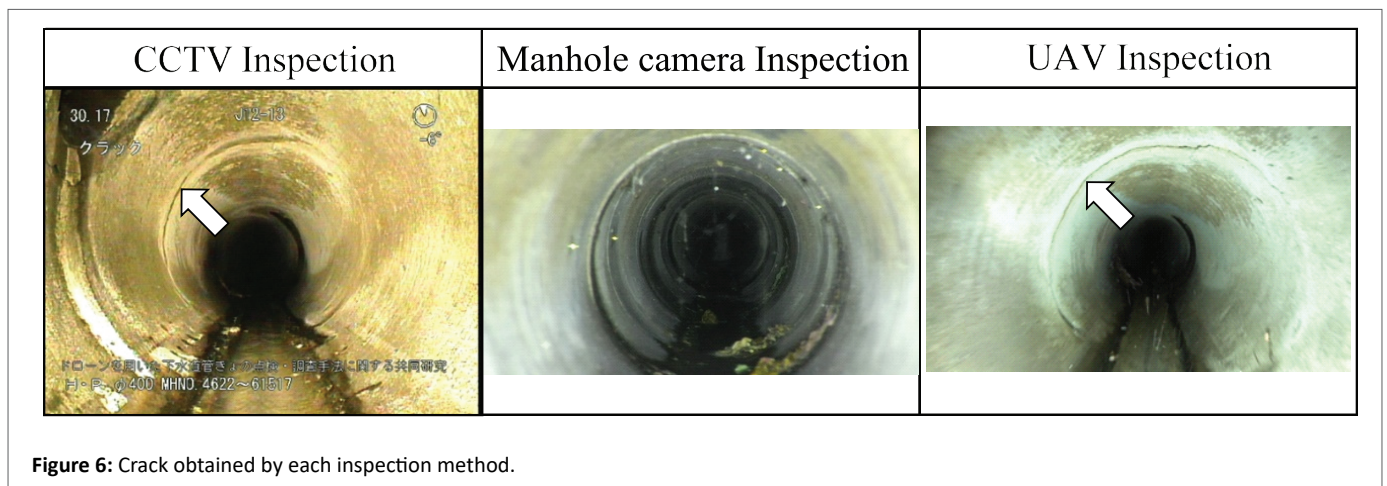
Figure 6: Crack obtained by each inspection method.

The results of CCTV are shown in table 4 and the levels of severities (A-C) are explained in table 4 as A being the most serious level. The criteria shown in table 5 was taken from the “Guideline for sewer management” issued by Japan Sewerage Works Association (JSWA) [4,9]. A manhole camera was also used to inspect the same section and the result was compared to that of CCTV. The visibility (screen clarity) was evaluated by how many defects the method detected for each item (Figure 6). Figure 6 shows a crack image obtained by CCTV, UAV and a manhole camera.
