Application of UAV for Sewer Pipe Inspection

Yusuke Inagaki, Hiroshi Ikeda, Yoshihiko Yato, Patrik Ken Takeuchi and Masatoshi Anakura*

NJS Co., Ltd., Minato-ku, Tokyo, Japan

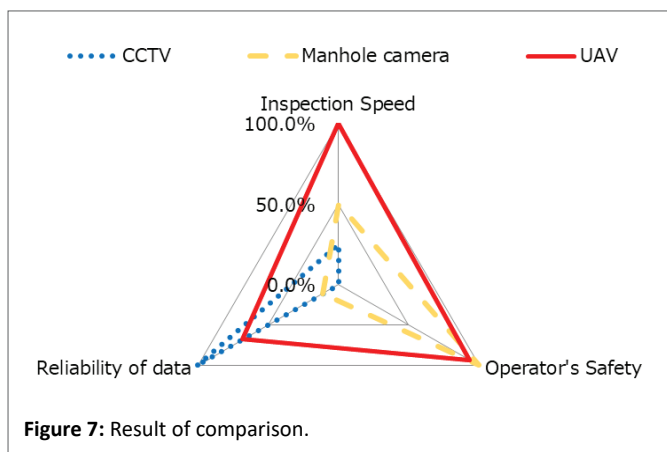
Figure 7: Result of comparison.

The matching rate (of 9 items, excluding “Deformed in Vertical direction” and “Attached deposit, grease” which were not applicable in this section) to CCTV was 11% for manhole camera and 68% for UAV. Out of these results, the rate for critical defects (items 1-5) was 8% for manhole camera and 74% for UAV and for maintenance-related defects (items 6-9), 22% and 44%.

UAV matching results at 74% for critical defects which affect structural integrity can be considered as a high matching rate. Among the items, corrosion, displaced joints and extrusion of lateral pipes scored a 100% match to the result of CCTV inspection. This
